Inspection Report

Property Address:
3302 Maywood Terr
Kansas City MO 64052

Chimney Inspection Disclosure

1. Chimney Inspection

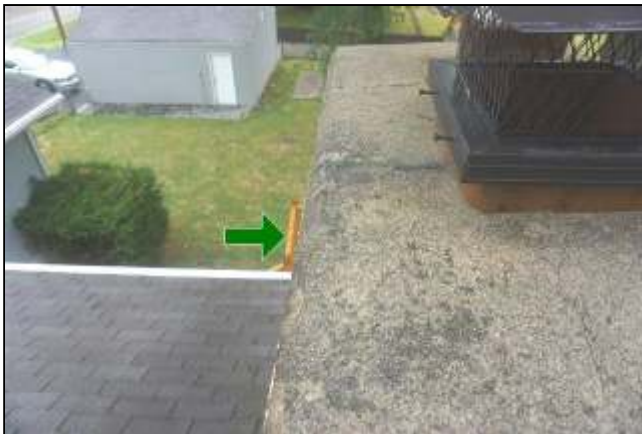
1.2 Chimney at Roof

The chimney crown and brick were in serviceable condition at the time of the inspection.

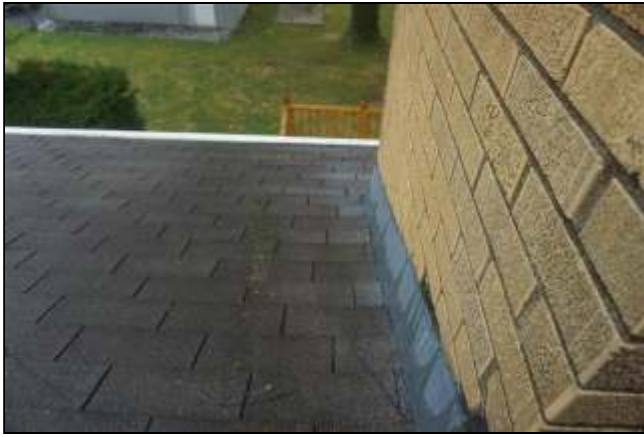
1.3 Roof Penetration Flashing

Although no failure was visible at the time of the inspection, the chimney counter flashing will need sealant maintenance in the future to prevent moisture intrusion into the attic/home or wall structure.

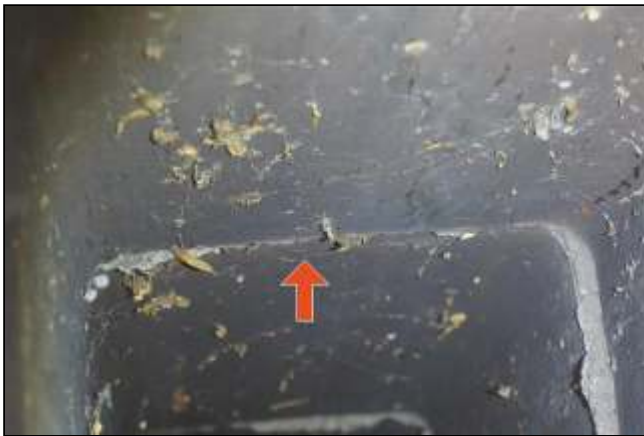
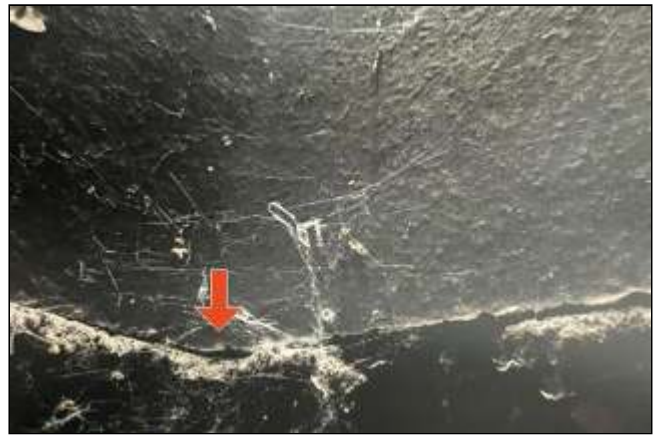
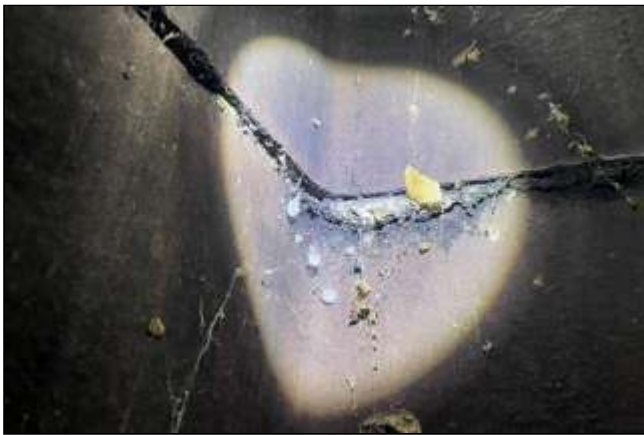
1.4 Flue

Some of the flue mortar joints were deteriorated at the time of the inspection. In order to protect the chimney structure, a flue liner should be installed or the flue re-mortared.

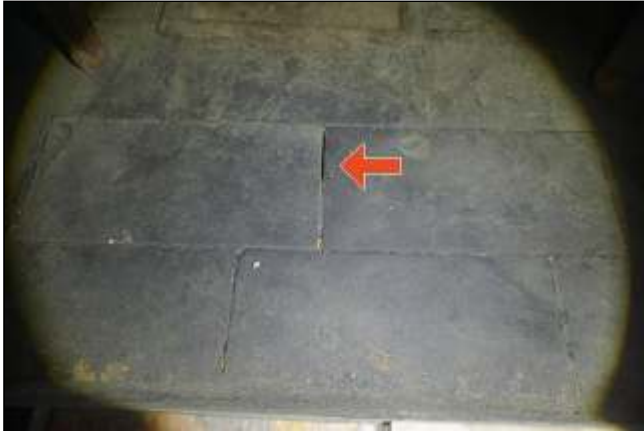
Example-Firebox

(1) Firebrick in the firebox and smoke chamber had areas of mortar deterioration that needed to be repointed.

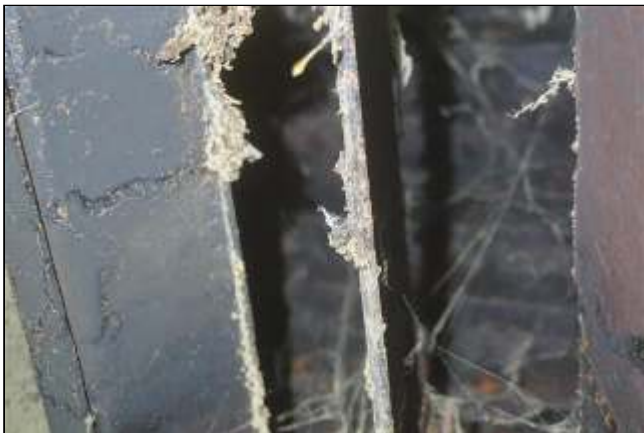
(2) One of the dampers did not fully close due to excessive soot build-up at the time of the inspection.

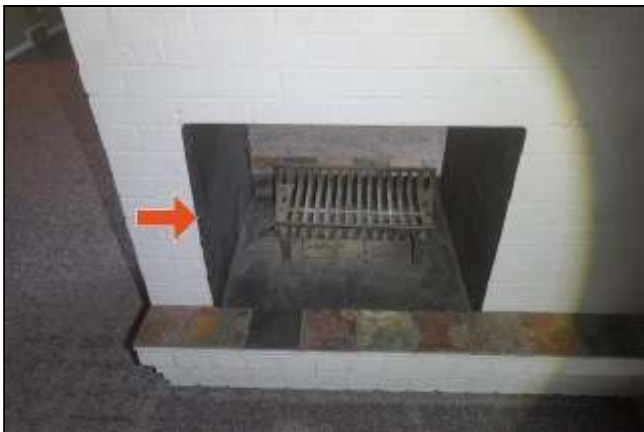
1.8 Screens & Grate

The fireplace was missing spark barriers that prevents sparks from escaping and potentially causing combustible materials to catch fire outside of the fireplace.

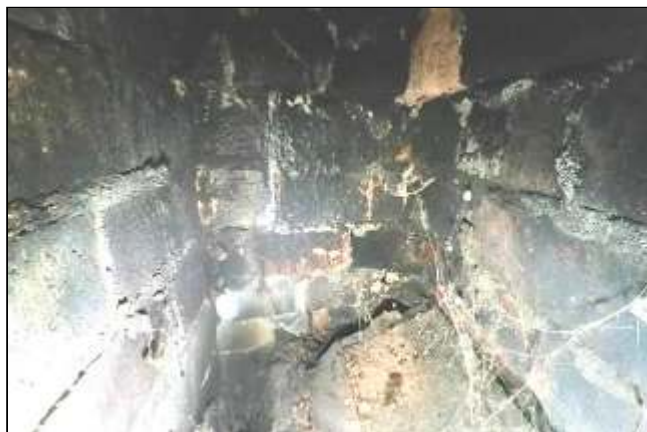
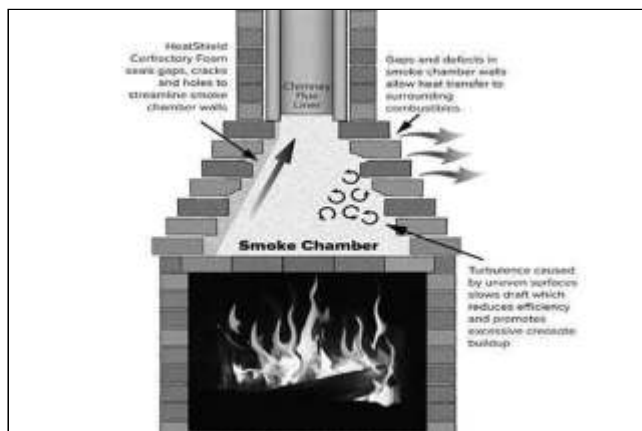
(1) The smoke chamber had no heat shield or parge coat installed at the time of the inspection. Although not required when the home was built, current standards require that smoke chambers be smooth to reduce turbulence to prevent the possibility of toxic products of combustion entering the living space.

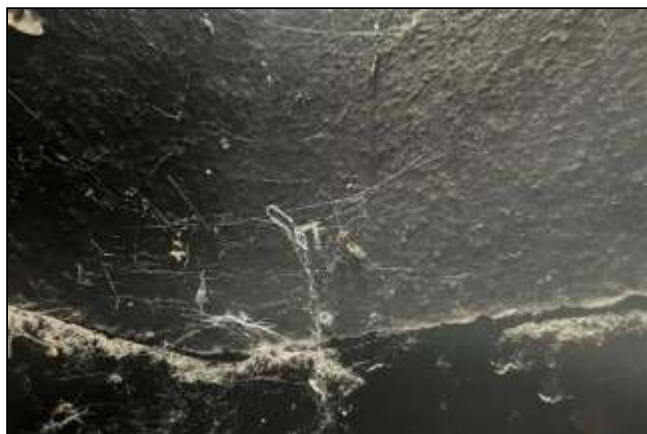
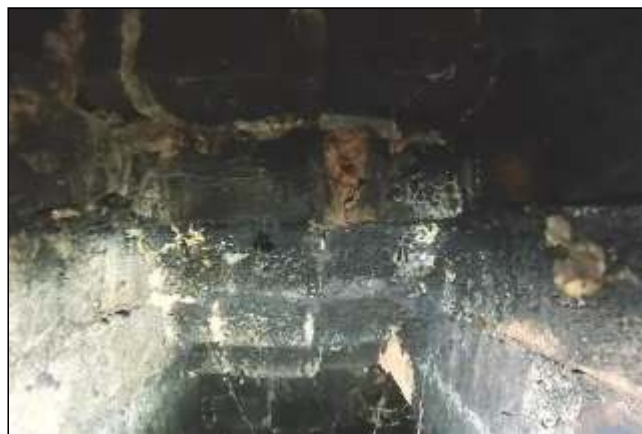
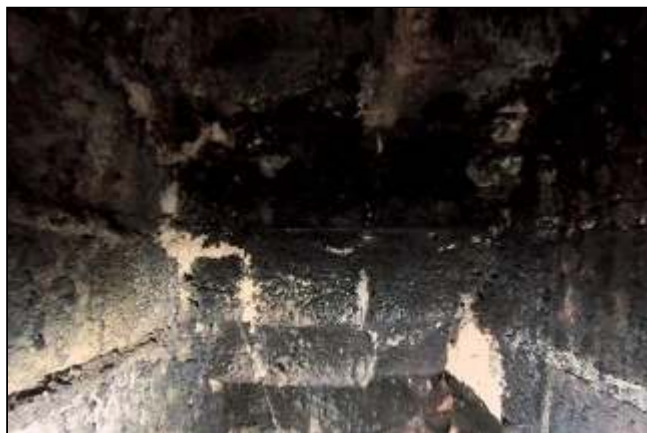
(2) The smoke chamber and lower flue had excessive soot or creosote build-up and needed to be cleaned at the time of the inspection.

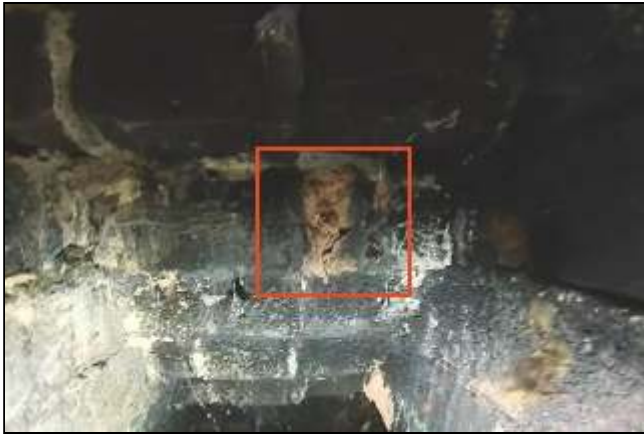
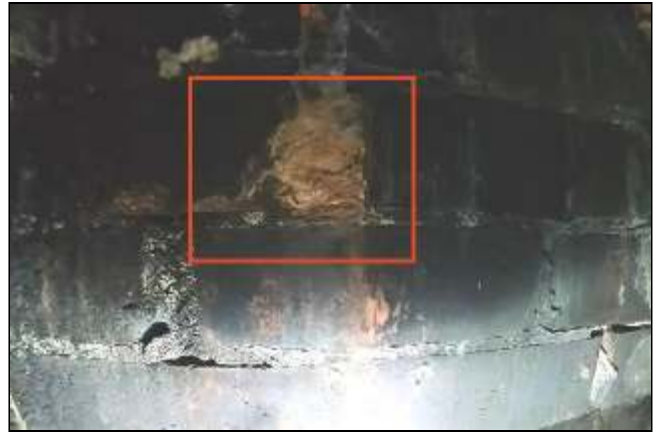
(3) Although the chimney crown and exterior brick was in serviceable condition, some of the bricks in the smoke chamber were crumbling or spalling from previous moisture intrusion. The inspector recommends correction by a qualified masonry contractor or chimney specialists.

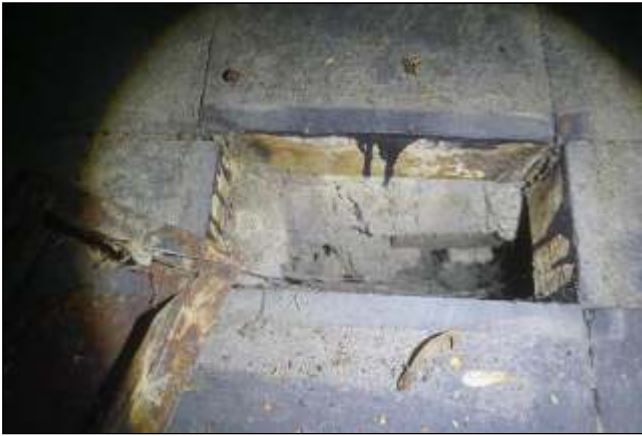
(1) The ash dump needed to be cleaned at the time of the inspection.

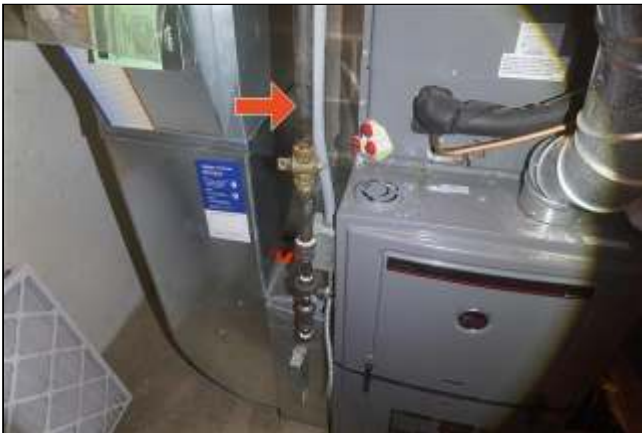
(2) The ash dump access door in the basement was blocked by the air handler at the time of the inspection. The inspector recommends having the access door moved to the exterior or providing a safe pathway so ashes can be properly removed when needed.

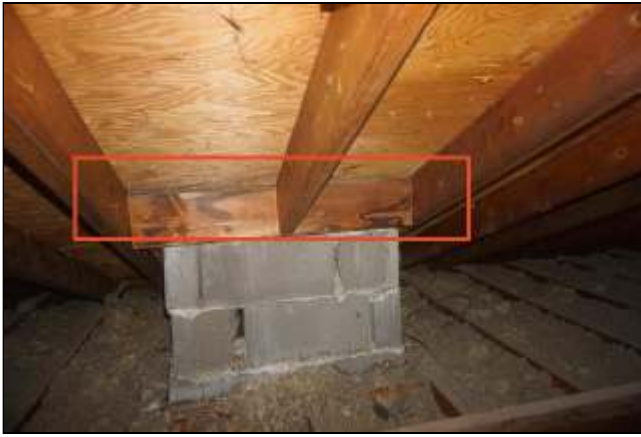
(1) **(MM)** Stains in the attic around the chimney appeared to be the result of moisture intrusion from deteriorated or missing sealant on the chimney counter flashing. Although the moisture meter showed no elevated levels of moisture present in the stained areas at the time of the inspection, flashing leaks can be very intermittent and any area that has evidence of leakage should be monitored to ensure that leaks have been corrected, If any leak is still present, it should be repaired.

(1) **(MM)** *Stains in the attic around the chimney appeared to be the result of moisture intrusion from deteriorated or missing sealant on the chimney counter flashing. Although the moisture meter showed no elevated levels of moisture present in the stained areas at the time of the inspection, flashing leaks can be very intermittent and any area that has evidence of leakage should be monitored to ensure that leaks have been corrected, If any leak is still present, it should be repaired.*

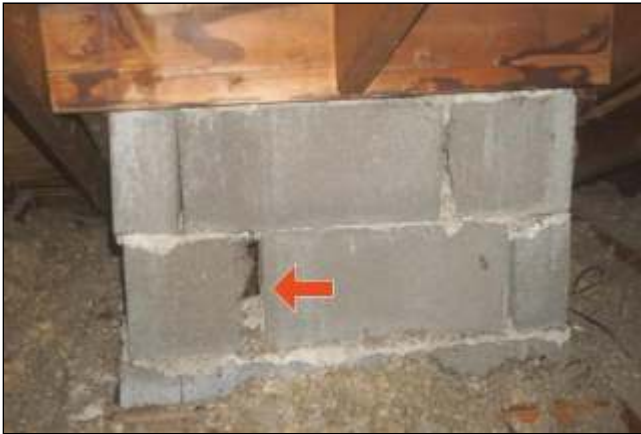
(2) The concrete block chimney in the attic had areas of deteriorated or missing mortar and evidence of movement. This may allow the toxic products of combustion to enter into the attic and is a potential source of ignition to the roof framing. The inspector recommends an evaluation and repairs by a qualified masonry contractor or chimney sweep before the fireplace is put into service.
